U.S. Department  
of Transportation

**Federal Aviation  
Administration**

September 14, 2010

Based on numerous concerns from Aircraft Industries/LET model L-13 owners, this document provides clarification in response to our issuance of FAA AD 2010-18-05, dated August 25, 2010. This AD addresses a fatal accident which occurred to an L-13 Blanik on June 12, 2010 and affects the L-13 and L-13A Blanik gliders, all serial numbers. This letter is meant to provide information only and does not authorize, promote, or require any alternative actions or procedures.

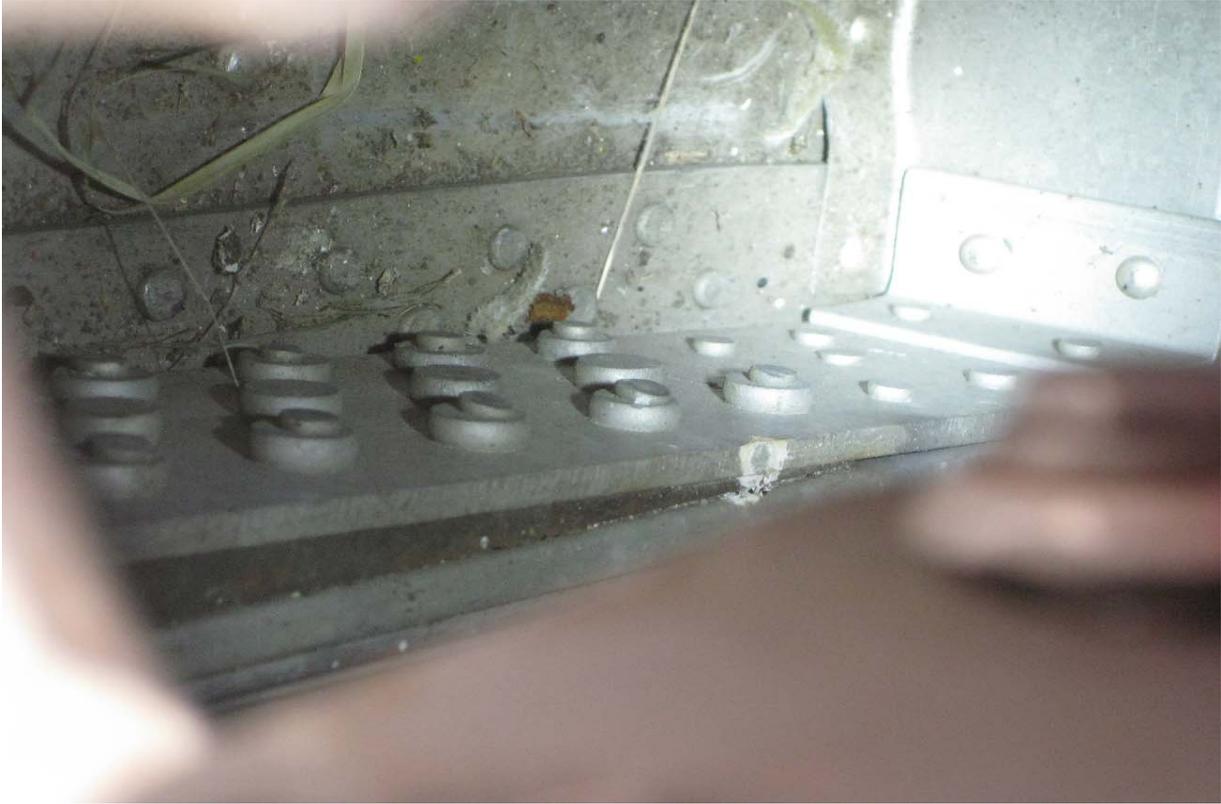
- a) Figure 1 of the above stated mandatory bulletin shows 3 rows of rivets on the inboard side. When viewing the splice joint rivet pattern from the wing skin, only 2 rows of rivets are shown. This indicates hidden rivet heads lie between the lower aluminum flange strap and the wing skin. These hidden rivet heads will never be inspected using a simple visual method as required in the bulletin. See the attached Photos 1 and 2.

**Photo 1: View of the spar cap splice joint from inside the wing**

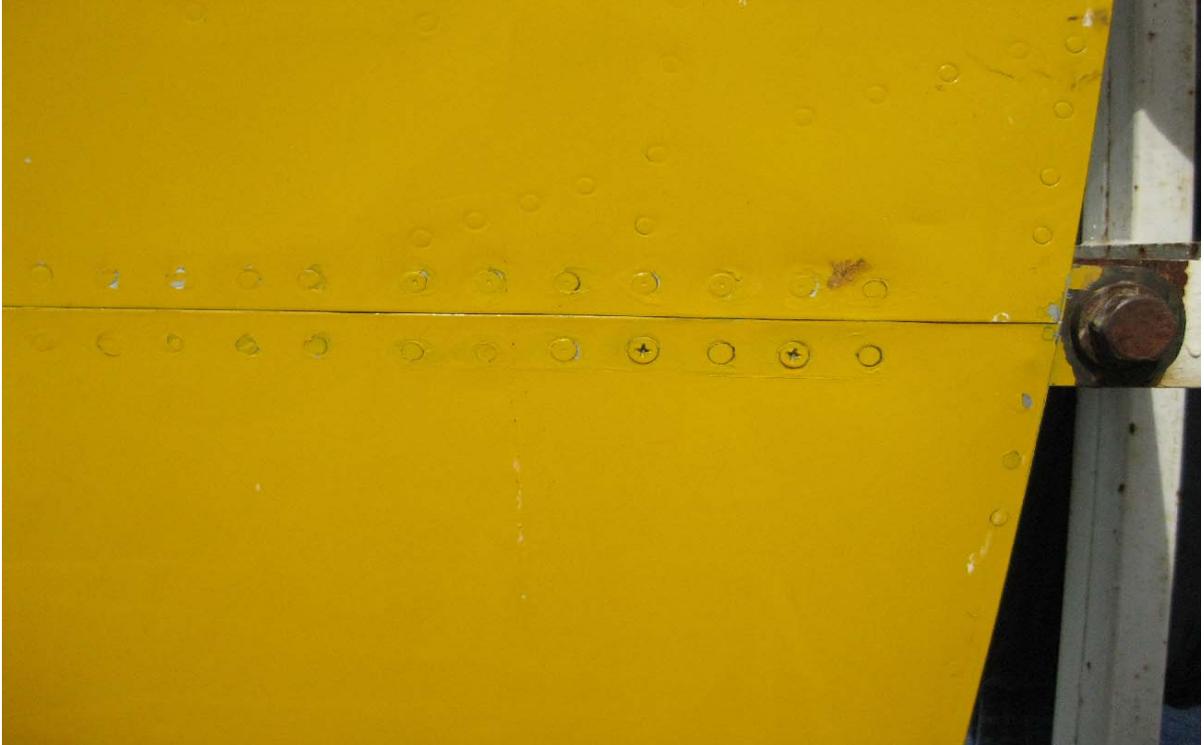
**Photo 2: View of spar fastener pattern from the wing skin**

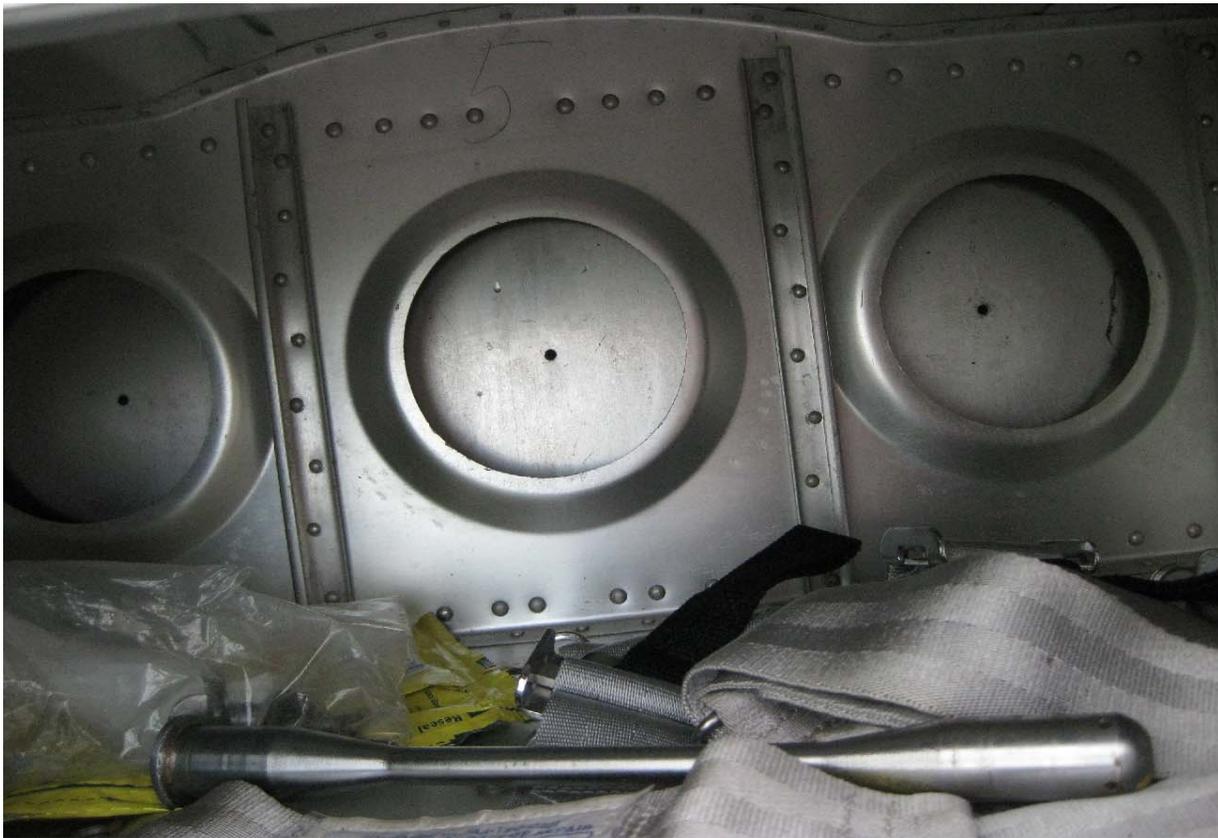
- c) Figure 2 of the Mandatory Bulletin shows the inspection area of the fuselage lower spar. This spar is situated between 2 bulkheads and is not accessible when using a hand-held magnifier. The use of a boroscope with sufficient magnification would be more appropriate. See Photo 3.

**Photo 3: View of forward and aft bulkheads;  
Fuselage spars lay between these structures**

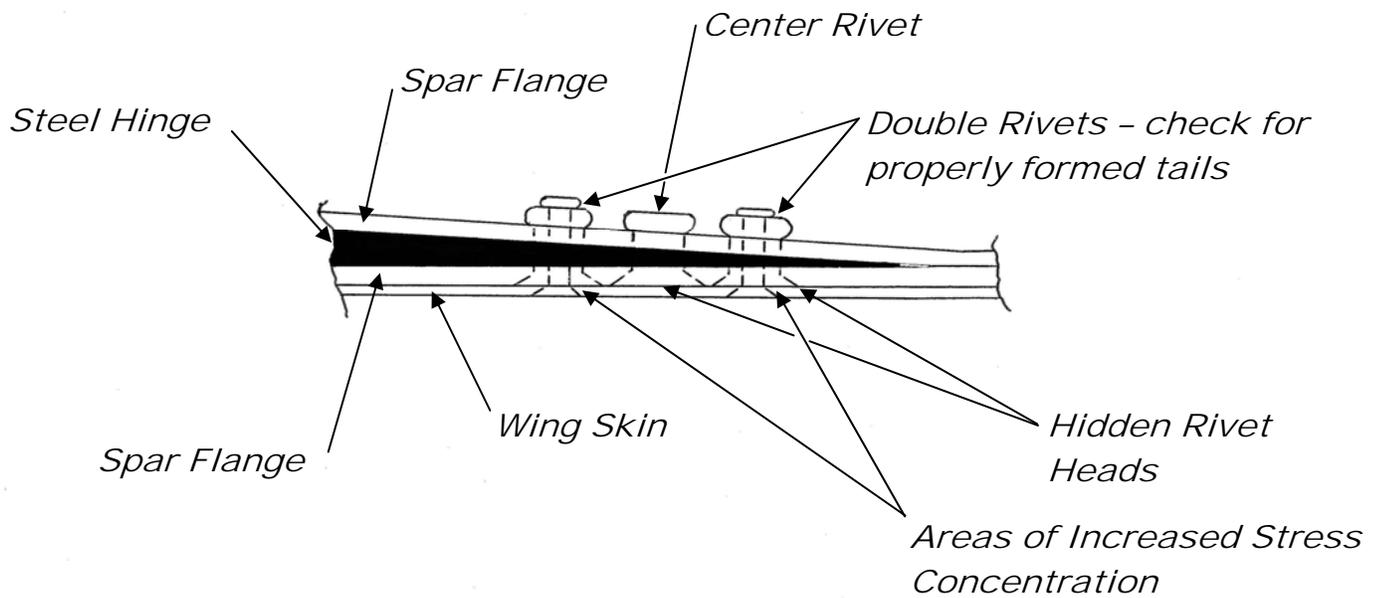
*Drawing 1*

- b) The design of the spar assembly utilizes a "double rivet" configuration such that a smaller diameter rivet is inserted within a larger rivet. This type of design makes it impossible to visually inspect the larger rivet head (see Paragraph "a" above) as well and introduces stress concentrations at the interface of the two rivet heads leading to reduced strength of the larger rivet. This type of design also increases difficulty during rework. In addition, on a few selected rivets, the height and position of the shop head side of the smaller rivet was not properly formed. See Drawing 1.
