ADVERTENCIA 292/DAG R2

Aeronautical Repair Shops, Owners and Operators of PIPER, CHINCUL, LAVIA aircraft, PA-25 series models, all S/N.

Presence of cracks / breakage of wing spars.

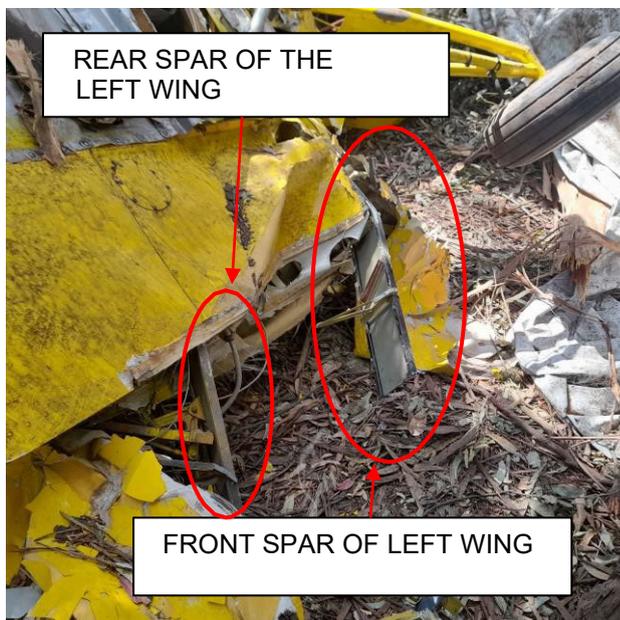
- 1- On 27-09-23 a PA-25-235, manufactured in 1980, with more than 2800 hours of TG, crashed due to the breakage of the front spar of the left wing. Below are some photographs showing the state of the spar after the accident.

In this photograph, with the aircraft inverted, you can see both spars of the left wing.

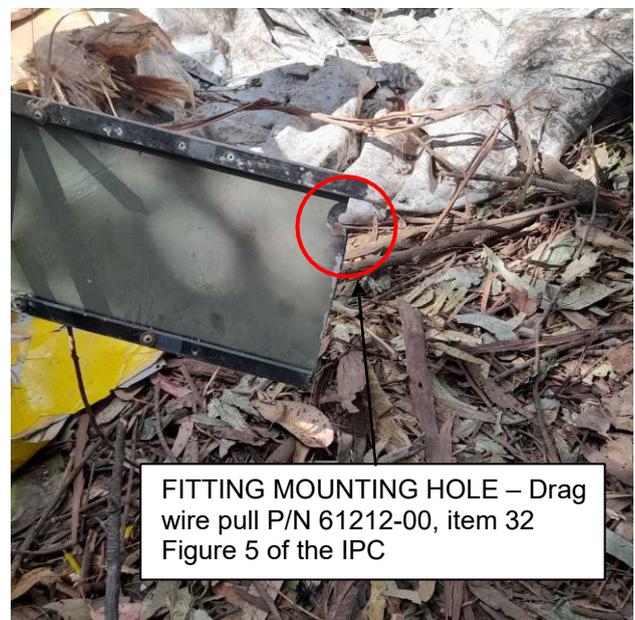
In this photograph, you can see the part of the front spar that was attached to the fuselage.

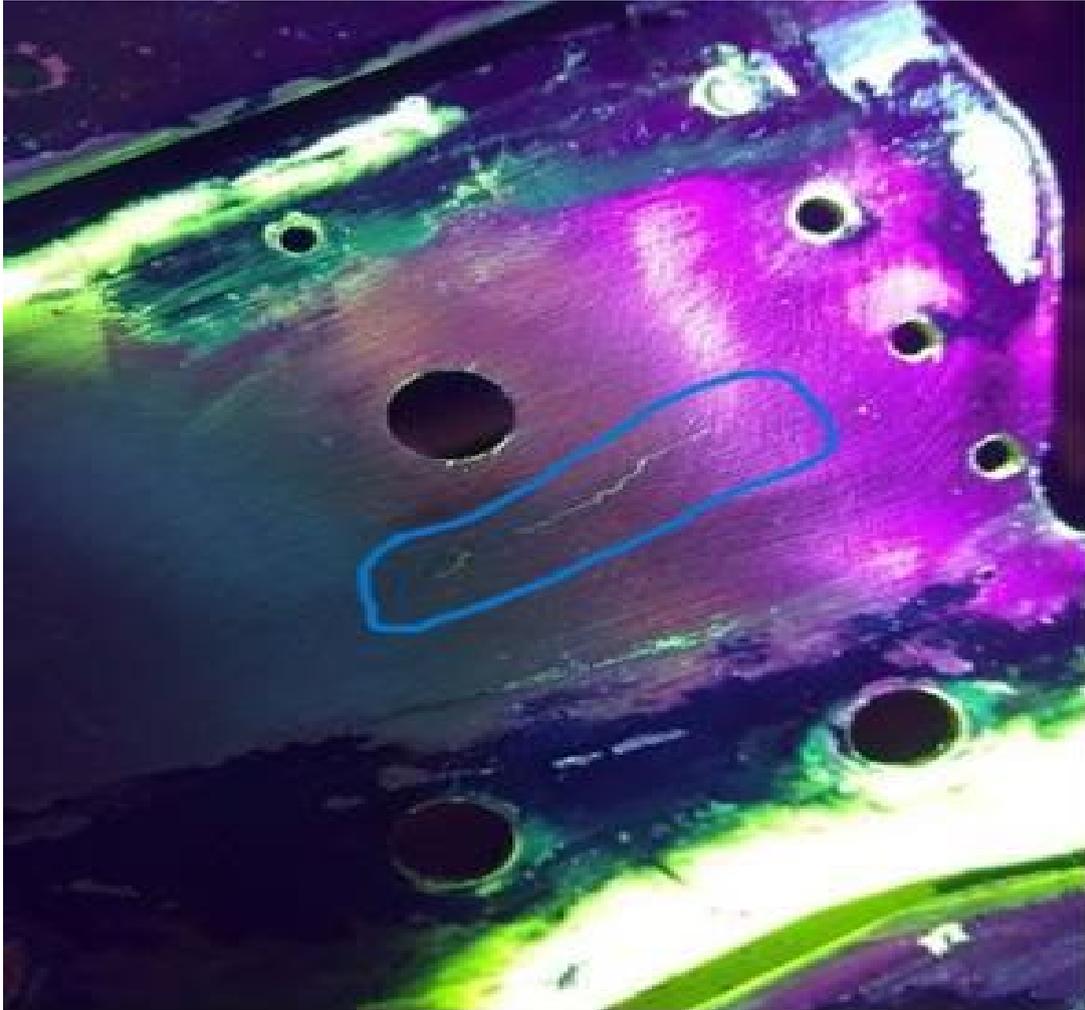
- 2- On the other hand, a WORKSHOP that has the scope to carry out NDT in its EEOO, sent us some photographs of a PA-25-235 spar, where a crack can be seen in the web of a spar. Unlike the accident described above, this crack:
 - a. Is located in the rear spar.
 - b. Is located close to the fixing area of the 1st compression tube.
 - c. It does not have a direction perpendicular to the spar, but longitudinal to it.
 - d. It doesn't appear that the crack starts in any hole in the spar.

One of the photographs from this report is below.

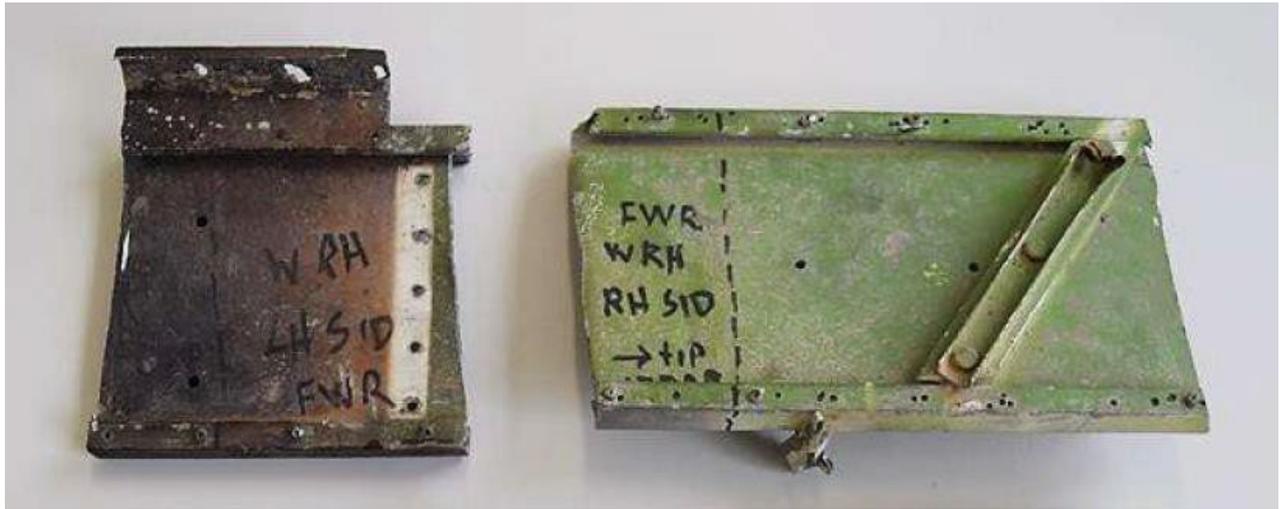
“Analysis indicates that there was a fatigue failure in one of the holes present in the front spar of the right wing. Fatigue cracks began inside the hole in areas with the presence of corrosion and plastic deformations. As the crack grew, a progressive reduction of the resistant section of the spar occurred, compromising its capacity to resist the stresses applied to the aircraft wing, resulting in a sudden failure due to the overload of the rest of the section of the front spar and, consequently, the overload fracture of the rear spar and the loss of structural integrity of the right wing.”

The report is accompanied by photographs showing the location of the front spar failure, one of which is attached below.

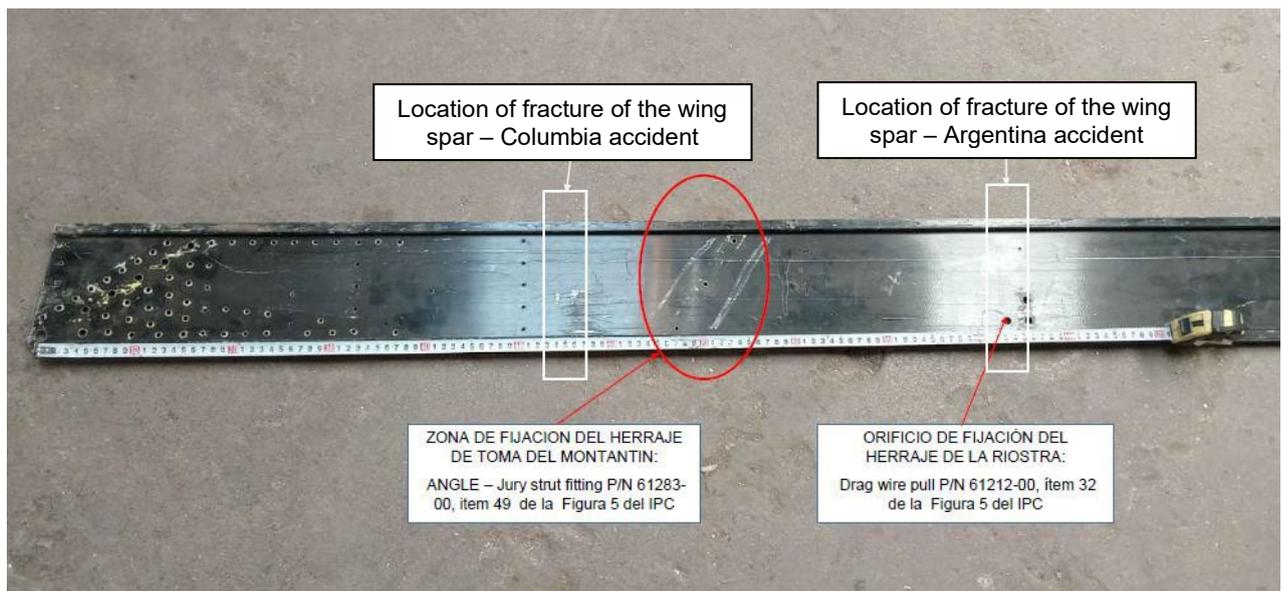
For a better spatial location on the front spar of the fractures reported in paragraphs BACKGROUND 1 and 3, the following photograph is attached.

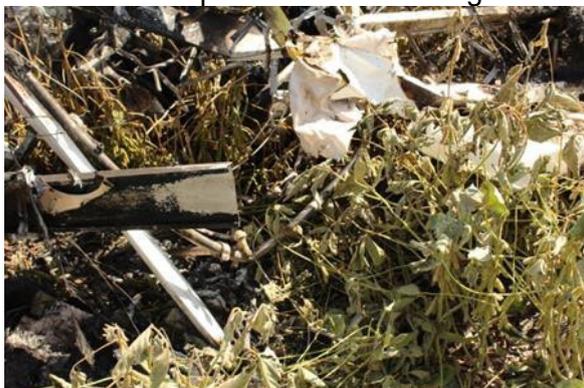
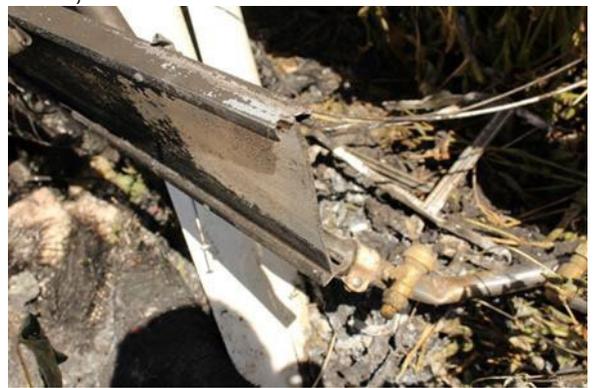
- 4- Following these events, the JST decided to resume the investigation of an accident that occurred in 2018, to a PA-25-235 aircraft, with a TG of approximately 4600 hours, manufactured by PIPER (USA). Investigators suspect that the cause of the accident could be similar to that of the aircraft indicated in paragraphs 1 and 3. Below are photographs of the state of the front spar of one of the wings of this aircraft, as it was found after the accident.

For this reason, due to the similarity in the way both spars broke, the JST has sent remains of the spar of this aircraft, together with remains of the aircraft that crashed in 2023 to a TEST LABORATORY, to try to determine, if possible, the cause of the breakage of the spars. The break observed in the spar is located approximately 1 mt. from the root of the wing.

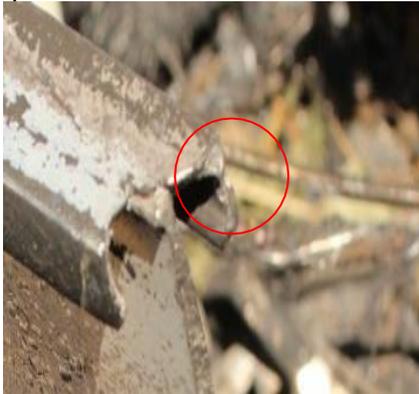
PA-25-235, ACC en 2018

- 5- After a few days of work with the remains of the spars, the laboratory has revealed, but without being able to confirm it yet, that there are signs that allow us to assume that the fractures would have been produced by fatigue processes originating in holes existing in the upper plates of the spars. In the following photographs of the spars of the aircraft that crashed in Argentina in 2018 and in 2023, it can be seen that the fracture fronts passed through holes existing in the plates, as in the accident that occurred in Colombia.

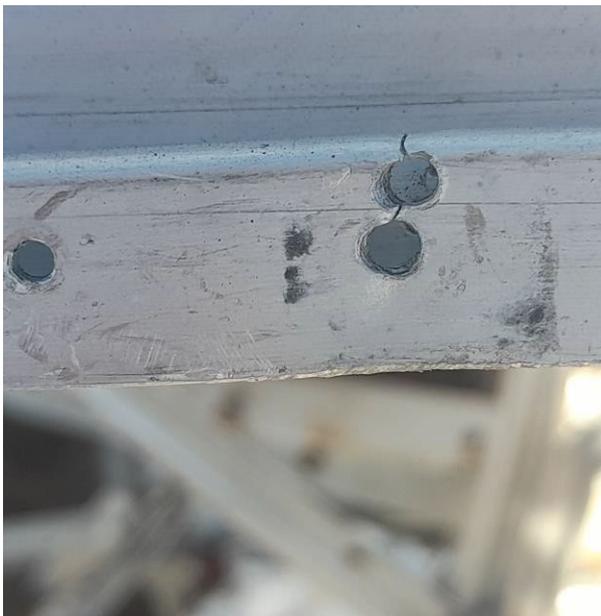
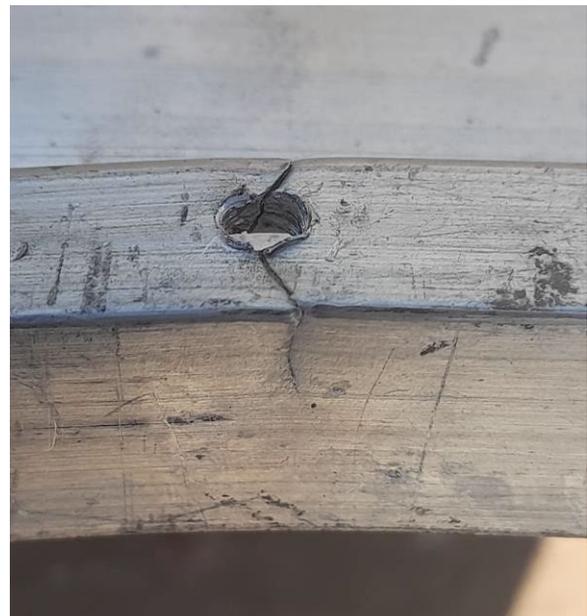
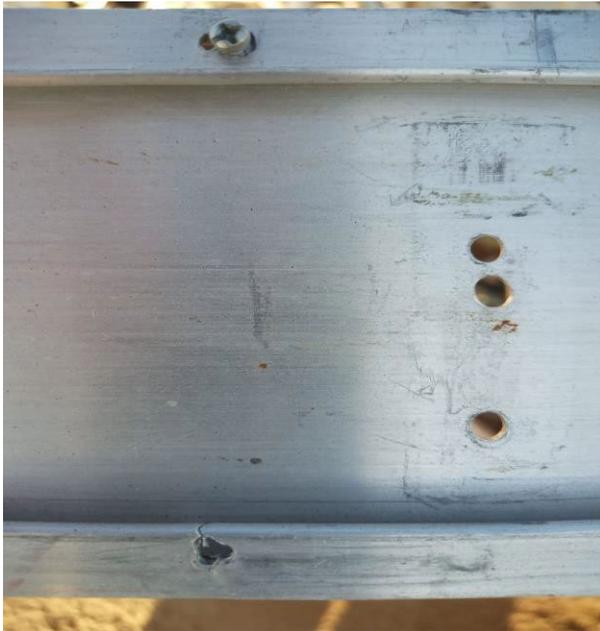
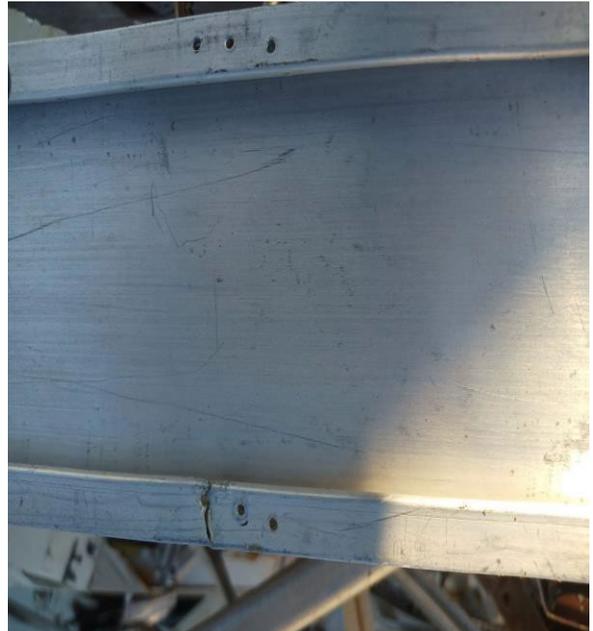
- 6- DAG personnel have been able to observe in a spar similar to that of the PA-25 series, a spar that was installed in a PIPER aircraft whose wings are constructed similarly to those of the PA-25, the existence of cracks that originated in the holes where the fasteners are placed to fix the leading edges and the ribs. Below are some photographs that show these holes and the cracks

- 1- Access is gained to the front spars, in an area covering 50cm to the right and 50cm to the left, of the P/N 61282-00 FITTING JURY STRUT (ITEM 48 OF FIGURE 5 OF THE IPC) strut attachment hardware, which is located approximately 700mm from the wing attachment hole to the fuselage, either by uncovering this section of the wings or through inspection covers.
- 2- Using a BOROSCOPE, inspect the UPPER CAPS of both spars for:
 - a. Fasteners incorrectly positioned as indicated in BACKGROUND 7.
 - b. Holes overlapping transversely in the beams, as can be seen in the 1st photograph of BACKGROUND 6
 - c. Overlapping holes, enlarging the original holes, as can be seen in the 3rd photograph of BACKGROUND 6
 - d. Cracks starting from one of the holes present in these areas.
- 3- If any of the defects indicated above are found, immediate replacement of the spar is recommended.

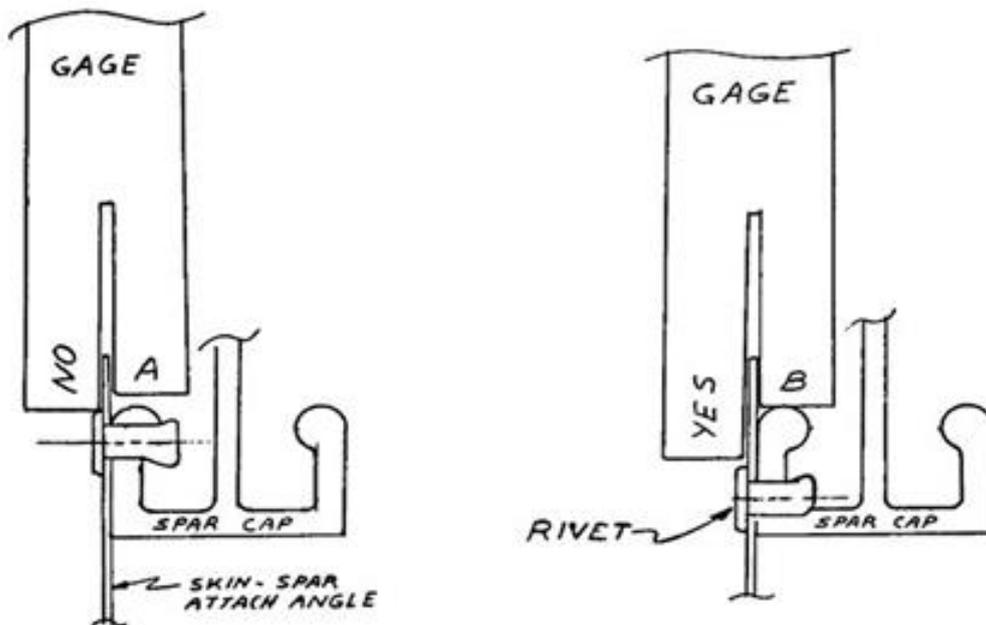
FIGURE NO.3 UNACCEPTABLE FASTENER
INSTL.

- 7- The FAA issued FAA AD 80-21-08 in 1980, applicable to PA-25 aircraft fitted with STC SA501SW, which is NOT APPLICABLE to the vast majority of PA-25 aircraft, but the interesting thing about this AD is that it defines sectors of the spar caps where the placement of fasteners, whether fasteners or rivets, is UNACCEPTABLE (PROHIBITED). The directive includes this graphic where these sectors are defined.
