PROJECT 140 - PA-25, WING FRONT SPAR ADDITIONAL HOLE DESIGN REPORT

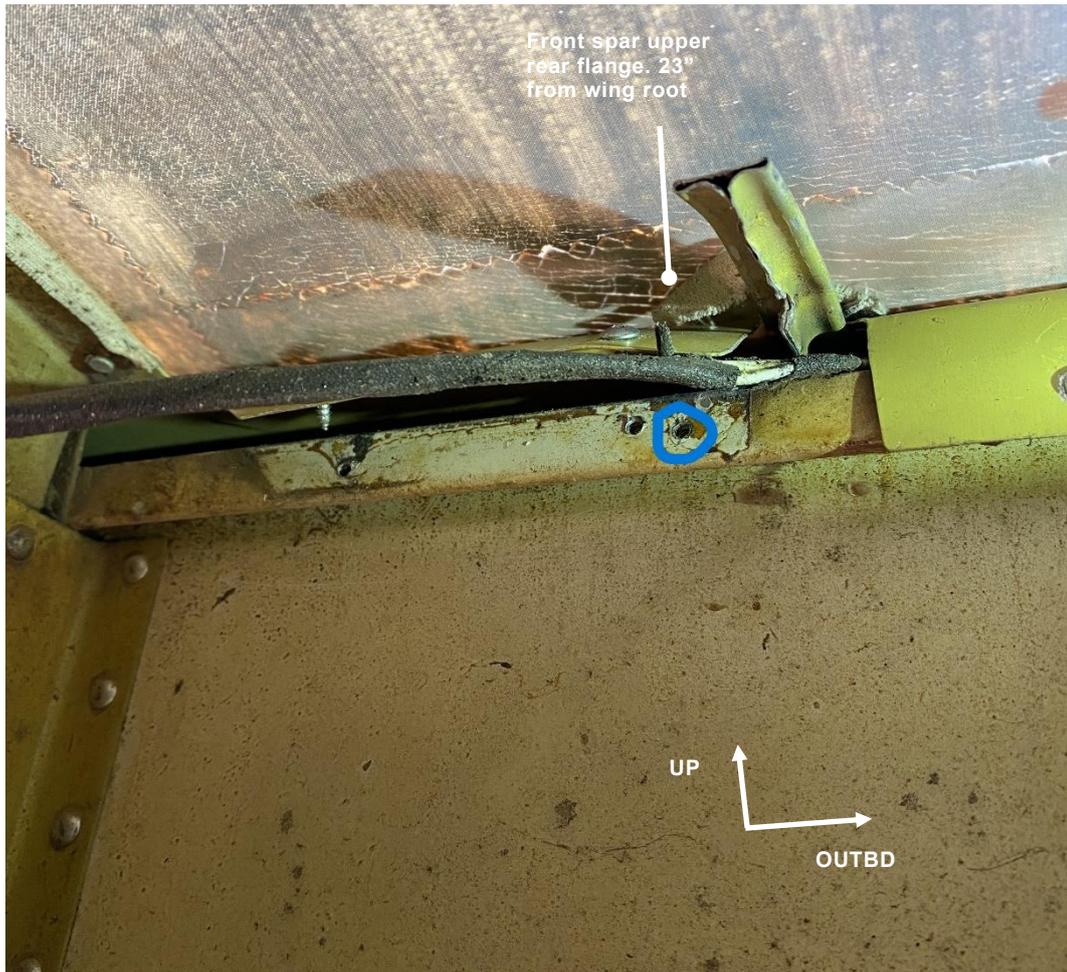
Figure 1-1: Location of Additional Hole, (viewing looking forward on front spar)

- 1.4 The wing has had one additional hole drilled into the front spar upper rear flange as shown in Figure 1-1, located 23" from the wing root. See also Figure A10-1 for a plan view location of the additional hole.

- 1.5 The additional hole is 0.500" outboard of the original hole which is currently used to secure the leading edge skin. Both the original and the additional holes are per the design configuration, whereby they are drilled at nominal $\varnothing 3/32$ " and then fitted with the self tapping screw which has an outside thread $\varnothing 0.114$ ".

1. The screws have been removed from the leading edge skin and the skin has been lifted up to show access to the spar extrusion.
2. Spacing between holes is 0.410".
3. The additional hole is positioned 0.260" from the top of the spar and 0.250" from the edge of the bulb. The vertical position of the additional hole is within the limits of the Laviasa go-no-go gauge referenced in SB 25-57-11, Ref [3]. See also Figure 2-1.

1.7.2 The additional hole is likely to be the result of the leading edge being replaced during one of the earlier re-builds. A visual inspection of the wing front spar did not find any repairs or damage near the additional hole site that would result in multi-repair interaction.

- 2.12 For the subject wing, the location of the additional hole is at ~23" from the wing root which is within the eddy current inspection zone (~19" to 41" from the wing root) as mandated by the AD 2024-05-01, Ref [2]. The repair design does mandate that the eddy current inspection is extended to include the additional hole.

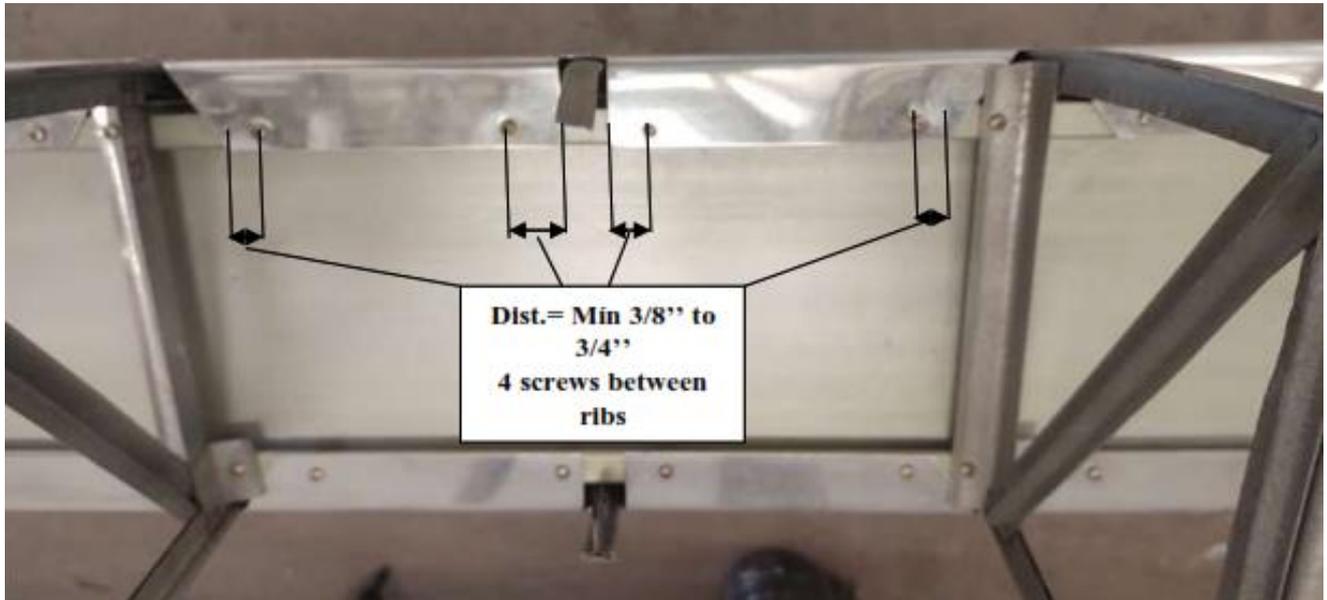
Figure 1-2: Design Configuration- Typical Skin to Spar Screw Positioning in Rib Bay

- 1.6 The design configuration, Figure 1-2, shows that within each rib bay, quantity 4 screws are used to secure the leading edge skin to the upper spar cap and 4 screws into the lower spar cap.

1. View is extract from SB 25-57-11, Ref [3], looking forward on front spar.
2. Quantity 4 screws (#4 x 1/4", PN 15086) per rib bay are used to secure the leading edge skin to the upper and lower spar flanges.

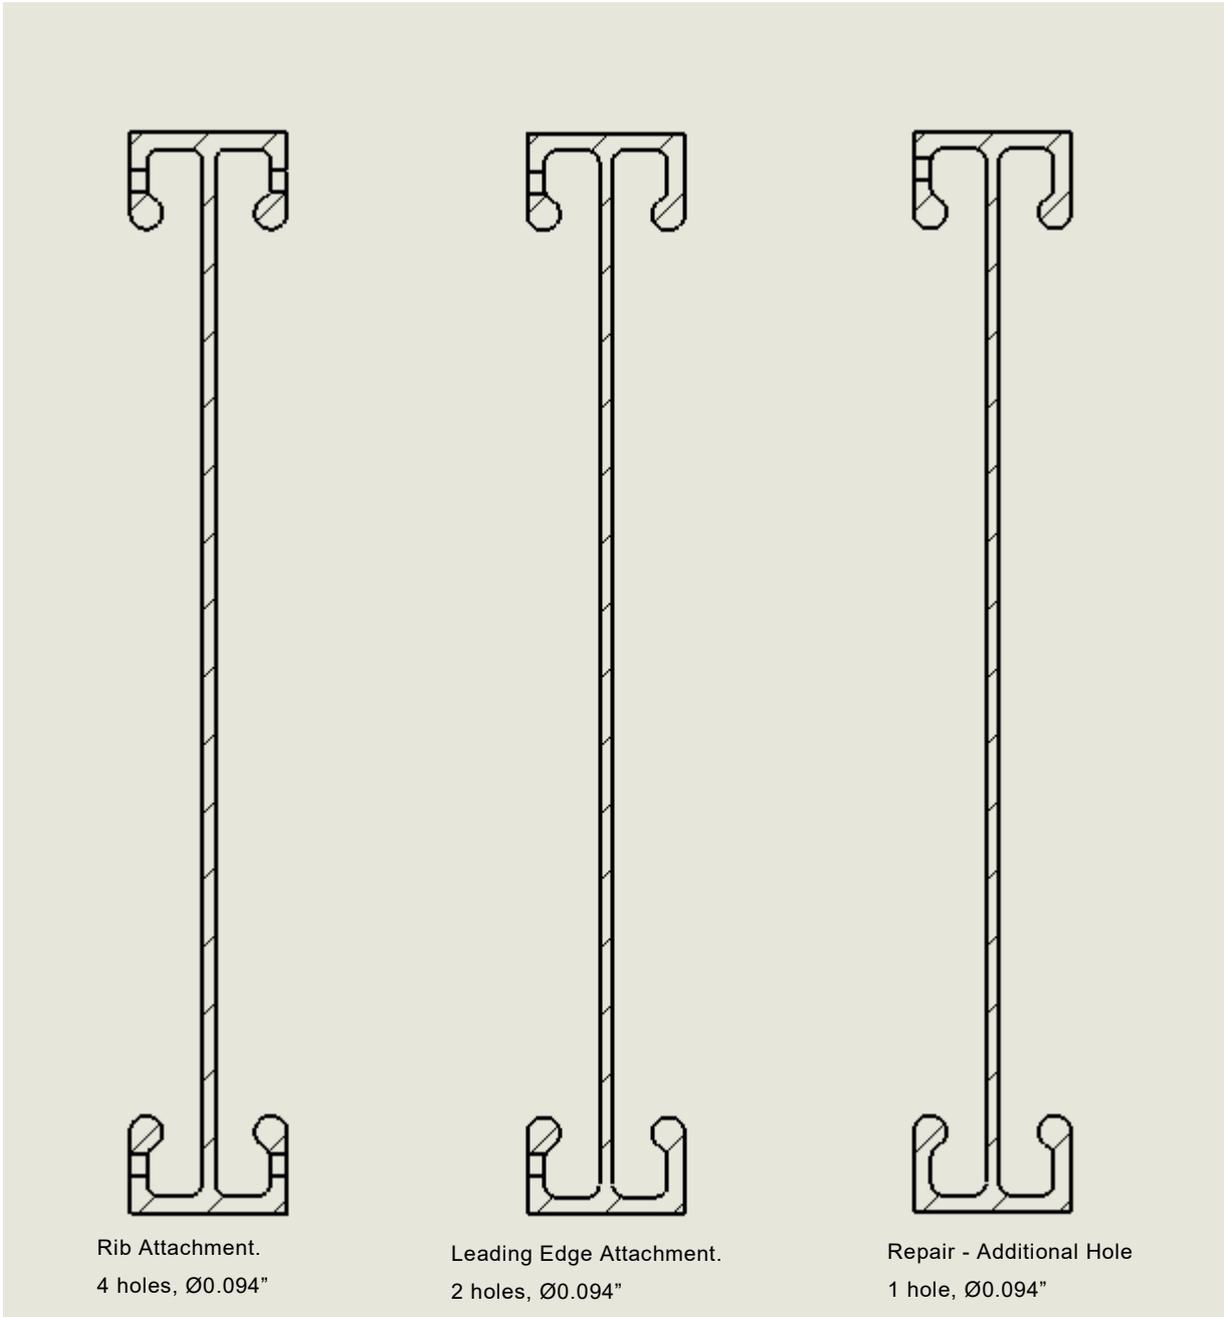
Figure 2-2: Design and Repair Configurations – Typical Spar Cross Section at Rib Attachment

- 2.2 The wing front spar acts as a beam that carries wing bending loads which are shared between the front and rear spars. In the original design, the critical spar cross section occurs where the fasteners in the upper cap align with fasteners in the lower cap resulting in some lost area. With the addition of holes in the spar flange that have some spacing in the spanwise direction and are of equivalent (or lesser) hole diameter, there is no change to the original spar section properties through a given bending plane.

- 2.4 The critical cross section through the wing spar is in-line with the rib attachments due to the rib-to-spar shear connections that are both fore and aft of the spar. The second most critical cross section through the wing spar is in-line with the design configuration rivets attaching the leading edge skin to the spar flange. The cross section of spar through the repair configuration additional hole is by inspection less critical than the design configuration cross sections. A summary of these cross section configurations is shown in Figure 2-5.

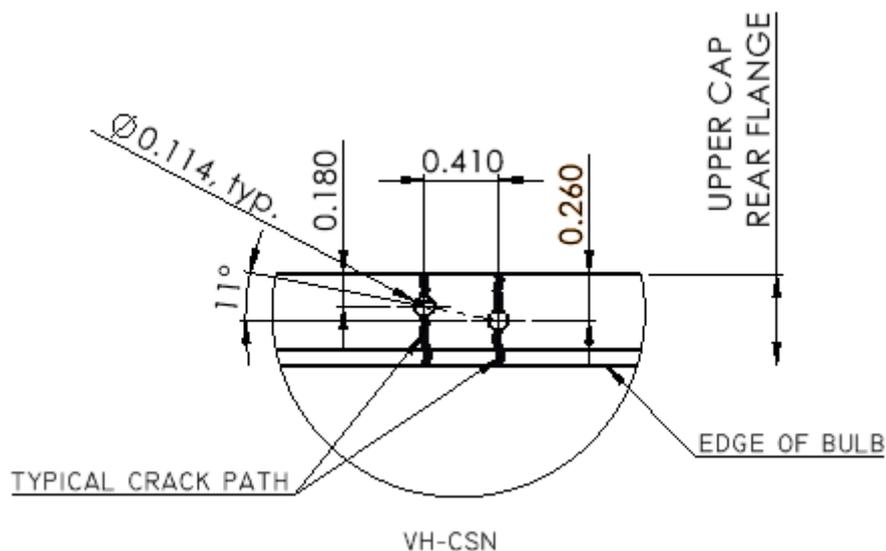
Figure 2-5: RH Wing, VH-CSN, Repair Configuration Holes, Predicted Crack Growth Paths

- 2.13 The additional hole position for the repair configuration for the subject wing is shown in Figure 2-5 and the approximate crack growth paths are shown. The following assumptions are made:

- Based on spanwise tensile load conditions in the spar cap, the cracks will propagate from the boundary of the holes at the points of highest stress concentration.

- The crack growth path will be in the bending plane, perpendicular to the spanwise tensile load direction.
 - The holes are sufficiently spaced apart in the spanwise direction such that, by inspection, crack interaction will not occur and hence not undermine any previously calculated growth rate (if it exists).

- 2.14 Based on the above, the fatigue strength (based on the safety by inspection methodology) of the subject wing in the repair configuration, is considered to be equivalent to the original design configuration.

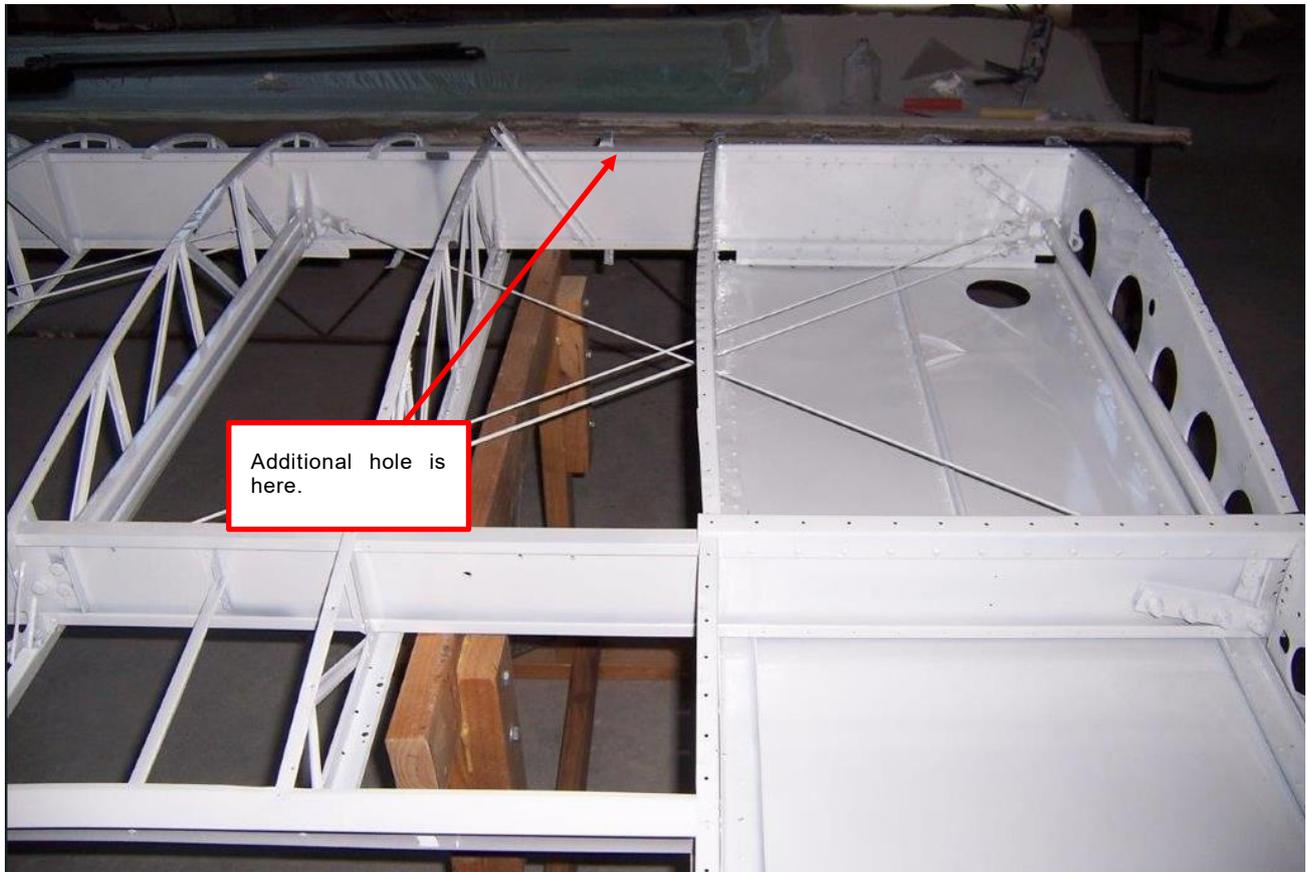
Figure A10-2: Fabric Removed, View looking Forward (Pictorial only; not the subject wing)

- 2.5 As shown in Figure A10-2, the additional hole is located in a rib bay that does not have additional local loads such as lifting strut attachments. It is located near a jury strut attachment, however, these loads are considered to be negligible as the jury struts are to limit the Euler buckling of the wing strut in compression.
