PROJECT 140 - PA-25, WING FRONT SPAR ADDITIONAL HOLE DESIGN REPORT

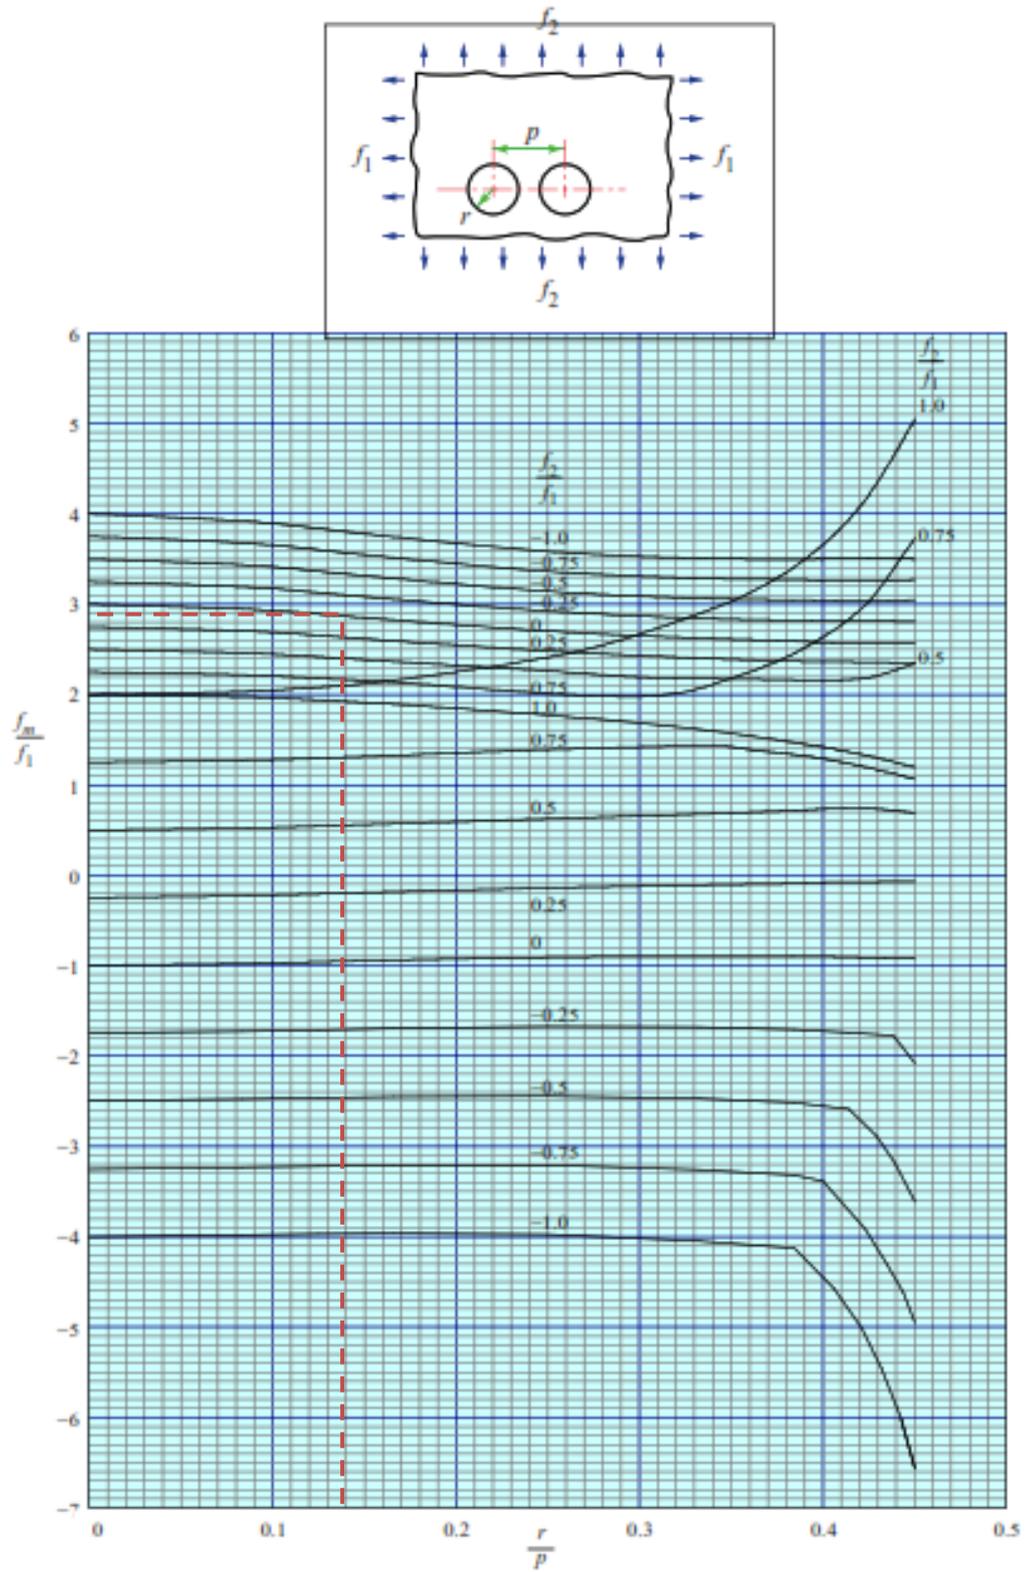
Figure 2-3: Extract from ESDU 67023, Figure 1

From ESDU 67023, Figure 1. See also this document, Figure 2-3

So, $kt \approx 2.93(f_1)$ at an angle of 11 degrees, which is less than the original configuration where $kt \sim 3.0$ (for tension loads).

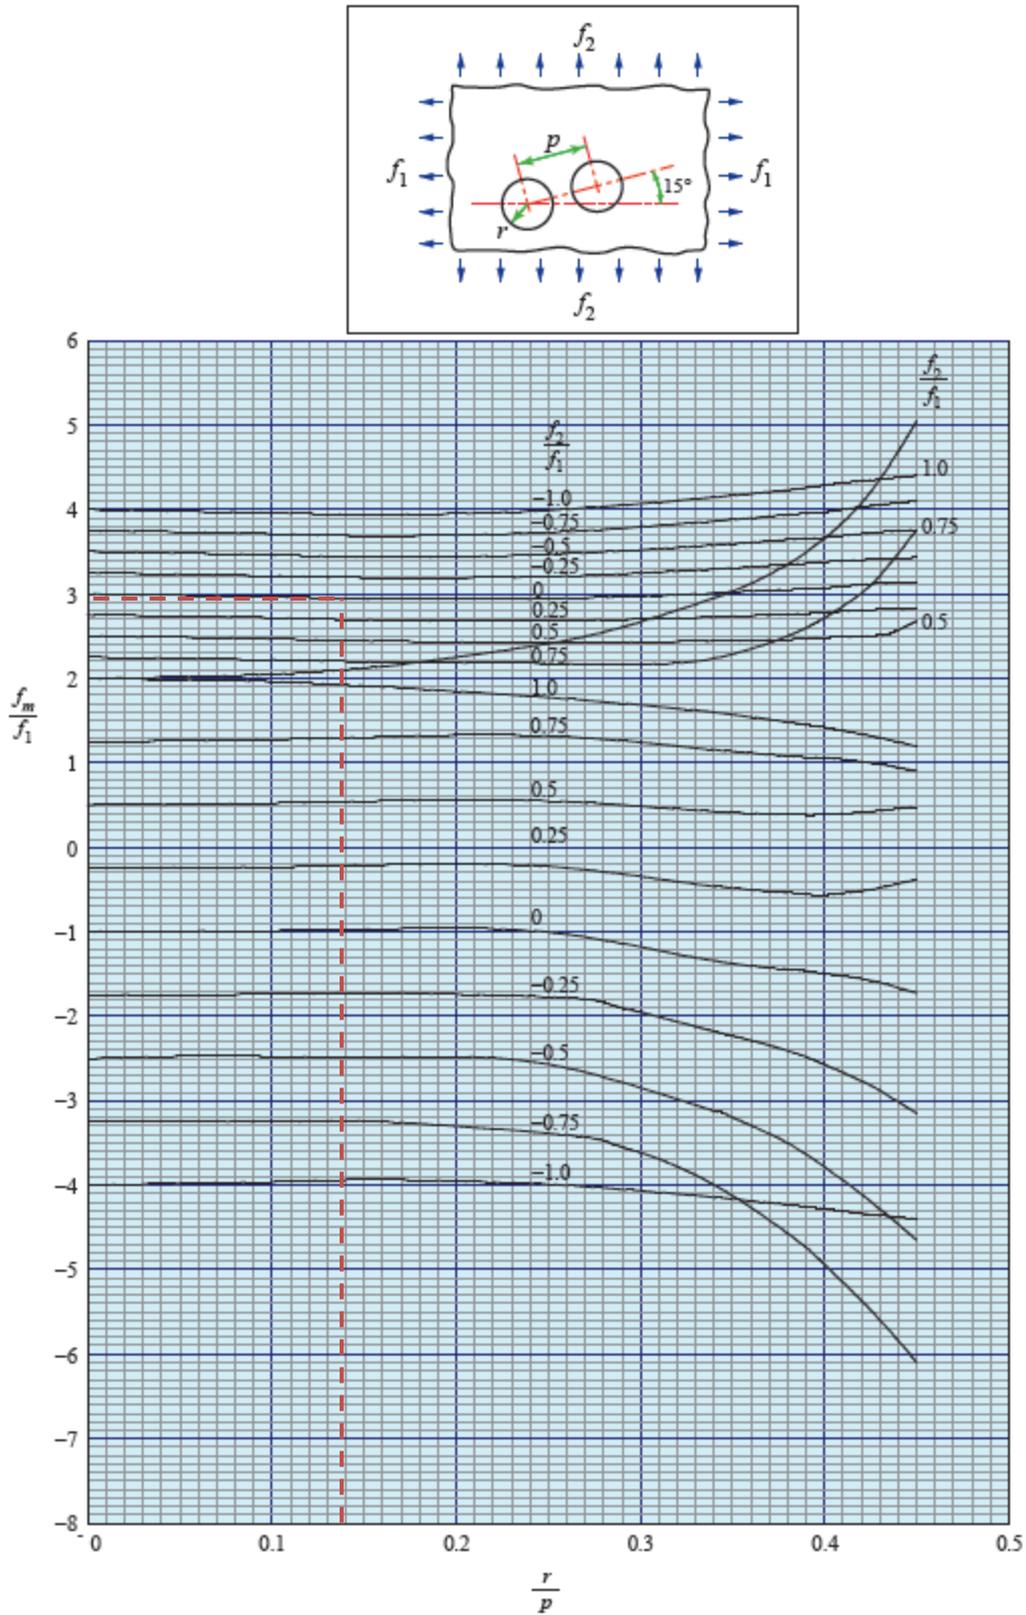
Figure 2-4: Extract from ESDU 67023, Figure 2

From ESDU 67023, Figure 1. See also this document, Figure 2-4

- 2.9 Based on the above, the fatigue strength (based on the safe life methodology) of wing, VH-CSN, in the repair configuration, is considered to be equivalent to the original design configuration.
